*Reprinted from Proceedings of In Situ '86  
GT Div., ASCE, June 23-25, 1986  
Blacksburg, VA*

BOREHOLE SHEAR TEST AND SLOPE STABILITY

Richard L. Handy, M., ASCE<sup>1</sup>

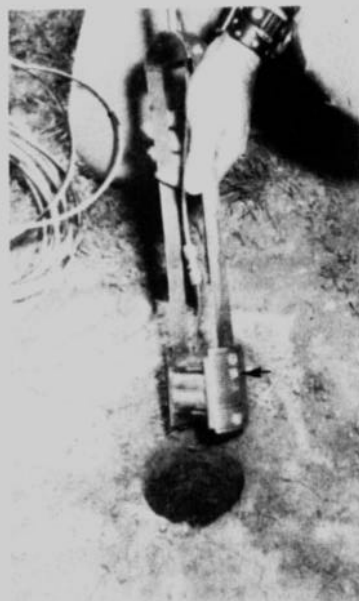
Figure 1. BST shear head with pore pressure sensor (arrow).

**Stage vs. Single Point BST** -- The BST is unique among in-situ test methods in giving direct evaluations of soil cohesion ( $c$ ) and friction angle ( $\phi$ ) at any particular depth. The key element of the instrument is the shear head, Figure 1, which opens laterally to apply a controlled constant normal stress acting on the soil through two opposed serrated shear plates.

After a 5-15 minute time for consolidation, the shear head is pulled, causing soil engaged by the shear plates to move with the plates, thus causing adjacent soil to shear. The pulling force is

measured and a maximum ascertained, which gives a single point on a Mohr-Coulomb failure envelope.

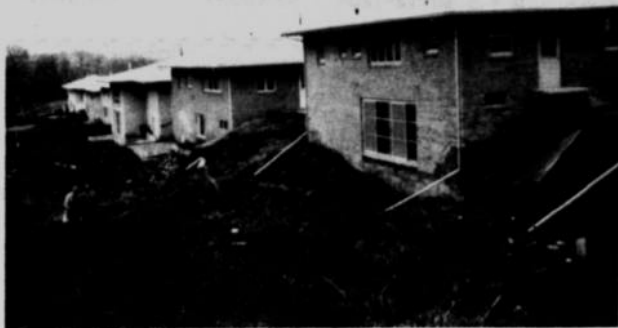
Figure 3. The Aurora Avenue landslide, Des Moines, 1964, and the site of some early Borehole Shear Tests.

Aurora Avenue, Des Moines. In 1959 a landslide developed in loosely compacted mixed MH and CH loess and glacial till fill, damaging and endangering four houses, Figure 3. Sliding was aggravated by restoring soil lost at the top, after which several abortive attempts were made to stabilize the landslide with underground drains, braced walls, and concrete piles. In 1963 two of the lots were successfully stabilized by the first reported use of drilled lime for this purpose (Handy and Williams, 1967), and in 1966 BST's were conducted in stable and in adjacent, untreated areas.

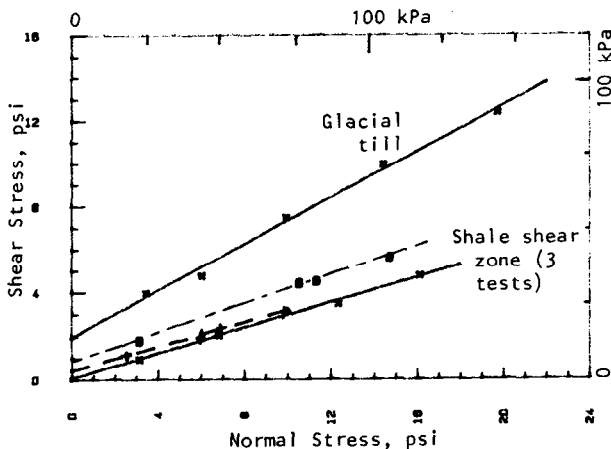
Figure 5. BST data from the Foster Avenue landslide.

Four BST's were conducted at three locations in the shale slip zone and one in the glacial till. Results, Figure 5, revealed a relatively narrow range of  $\phi$  values for the shale, so the tangent average  $\phi = 16.1^\circ$  was used in the analysis. As in the other studies,  $c$  was more variable, and an average value was used for the analysis prior to sliding.

From the BST data of Figure 5 and the assumed highest position of the ground water table at A one obtains a  $FS = 0.9$ , Table 1, suggesting either an underestimation of the average  $\phi$  or an overestimation of the maximum ground water level.

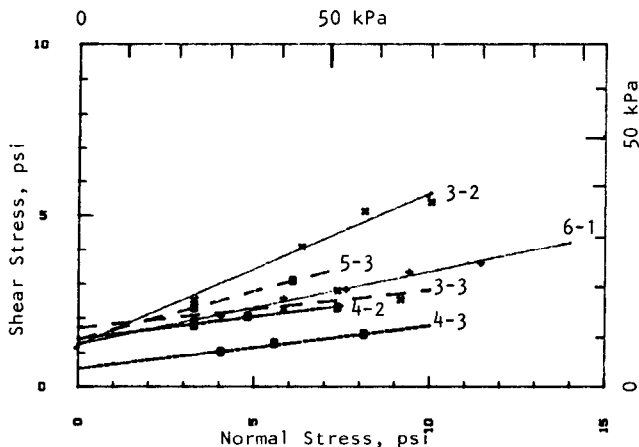
Figure 7. BST's for random fill.

Of the 10 BST failure envelopes obtained in the remaining dike sections, four were in the compacted embankment and six were in the underlying random fill soil. Friction angles are relatively uniform in the compacted fill (Figure 6) and variable in the random fill (Figure 7), whereas the reverse is true for cohesion. Results are summarized in Table 2.

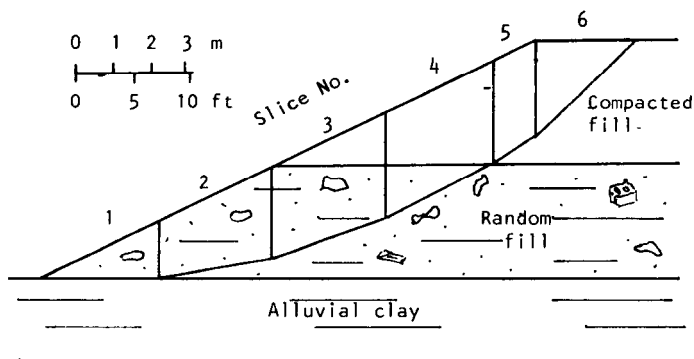
Figure 8. Lagoon embankment cross-section.

random fill, as shown in Figure 8. A simplified Bishop analysis from this figure gives  $FS = 1.28$ , still within marginally acceptable limits for safety.
